## ENERGY AUDIT REPORT

G.L.B Institute of Technology & Management

Month of Study: December- 2020

Energy Consultancy Services

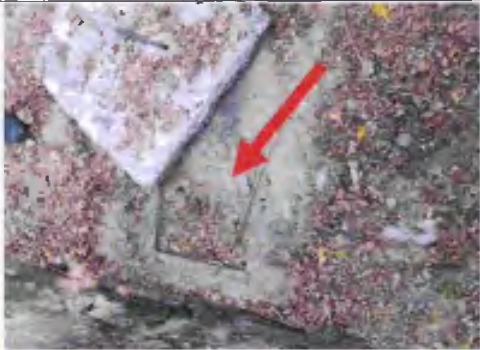
| s. no. | Images | Observations | Recommendations |
|---|---|---|---|
| 1. | | Earth pit was full of dust no earth strip and watering pipe visible | Pit should be empty, watering pipe and earth electrode connection should be visible so that during summer watering could be done to reduce the earth resistance values and status of connection may be seen. |

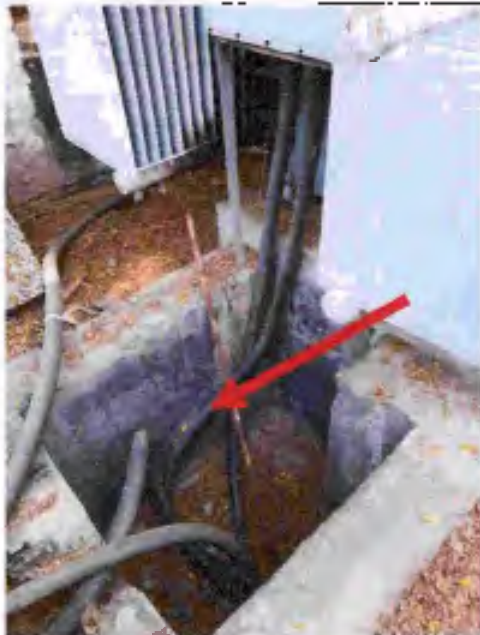
| s. no. | Images | Observations | Recommendations |
|---|---|---|---|
| 2. | | Cable trench was found open. It is a hazard and may be a cause of accident. | The cable trench should be properly covered. |

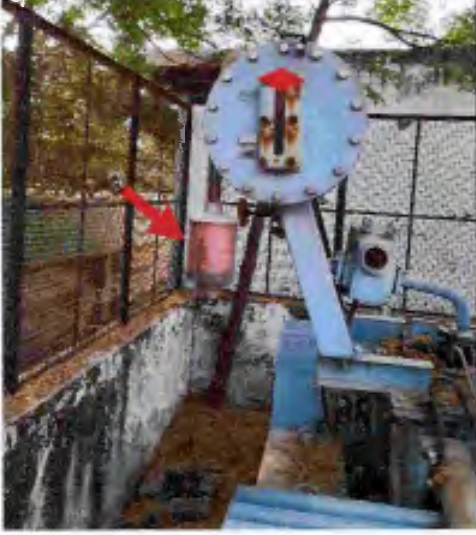
| 3. | | <p>Transformer breather silica gel became violet so it is full of moisture and out of function for old 630 kva transformer.</p> | <p>Replace it so that moisture may not enter inside the transformer on the other hand its color should be blue.</p> |

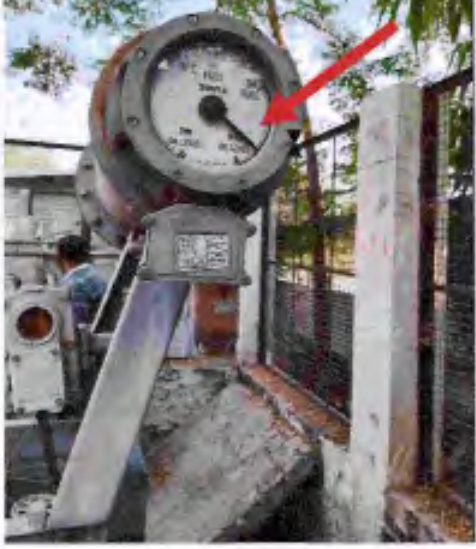
| 4. | | <p>Transformer oil was found fill up to full scale its glass indication also shows full .</p> | <p>As per rule oil level should be in between lower and upper level of indicator.</p> |

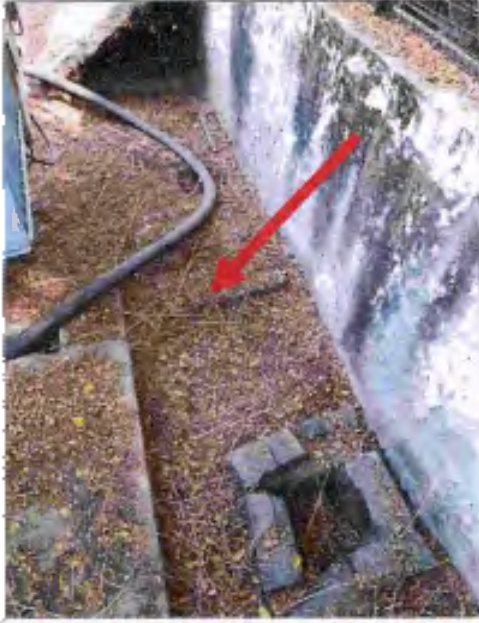
| 6- | | <p>Cable was not dressed, trench was uncovered and earth pit chamber found damage.</p> | <p>Dress the cable, cover the trench by putting slabs on it and repair the earth pit chamber as these are hazard and may be a cause of an accident.</p> |

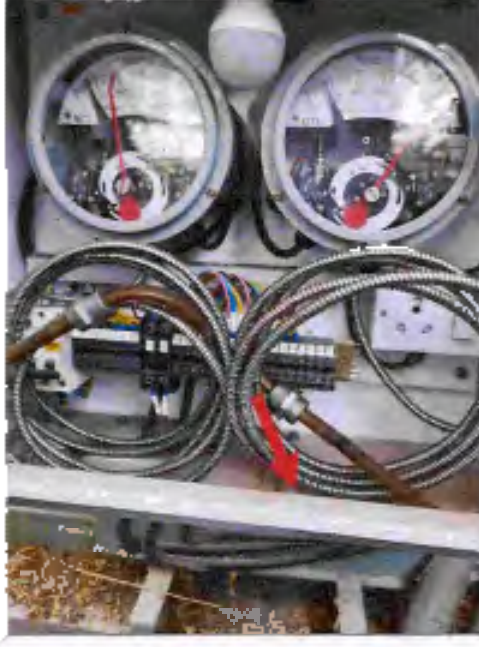
| 7- | | <p>Winding temperature indicator and oil temperature indicator for new 630 kva transformer were neither found connected nor set.</p> | <p>Set and connect them.</p> |

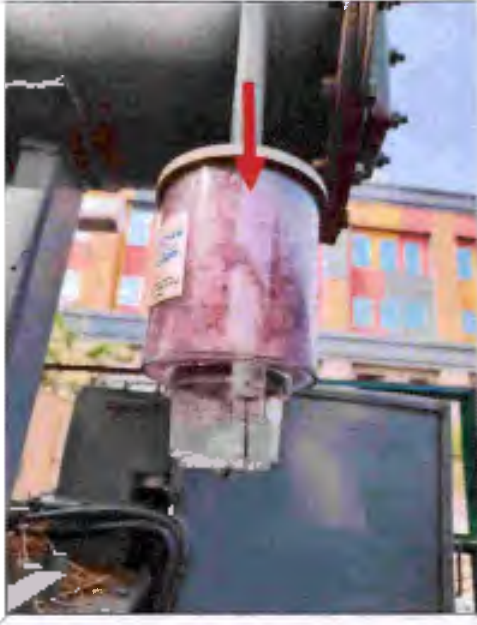
| 8- | | <p>Transformer breather silica gel became violet and out of function for new 630 kva transformer.</p> | <p>Replace it.</p> |

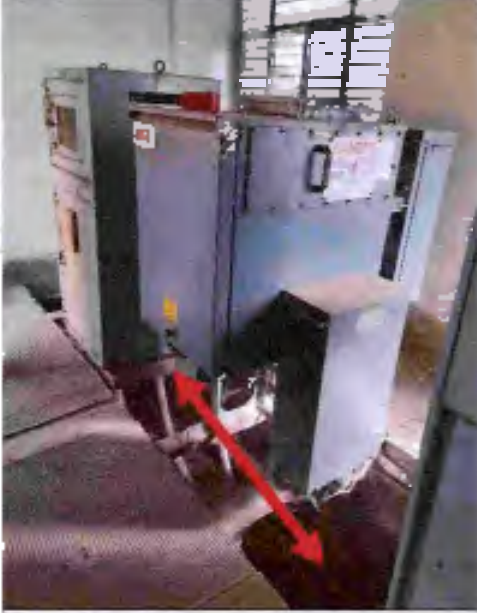
| 9- | | <p>11kv RMU units are used for both 630 kva transformer which is not o.k. Cable trench also found open.</p> | <p>11kv vcb should be used with full protection as RMU units are not much reliable. Trench should be covered as it is hazardous and may be a cause of accident.</p> |

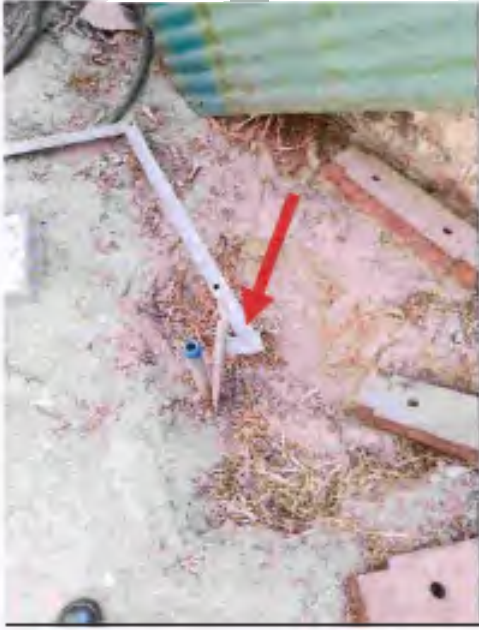
| 10- | | <p>This is not a proper way for maintaining the earth pit:</p> | <p>Make a proper earth pit .</p> |

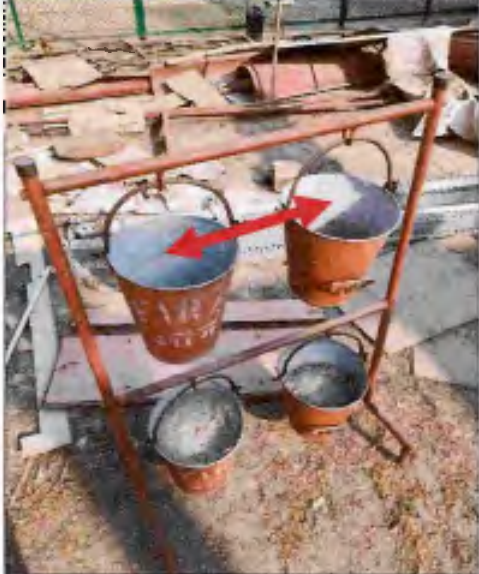
| 11- | | <p>Fire buckets are empty and not maintained.</p> | <p>These should be full of sand and properly decorated, painted and should be written fire on them.</p> |

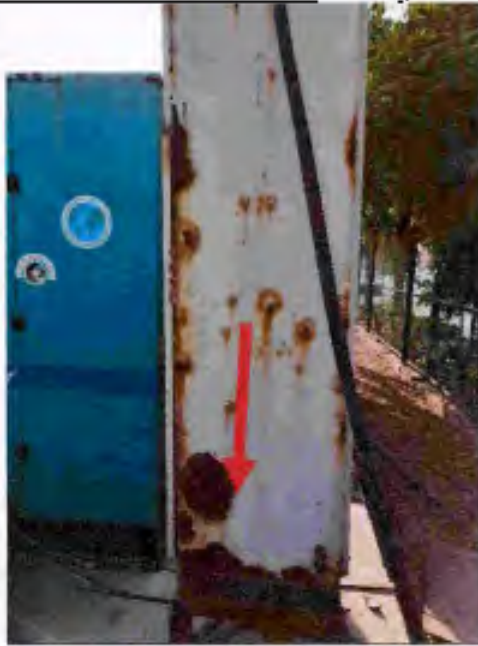
12-

D.G set's electrical panels are kept in open space near each D.G and being rusted due to rain water while these are mont in door type.

Either shifts the panels inside under the roof or febricate a canopy for them.

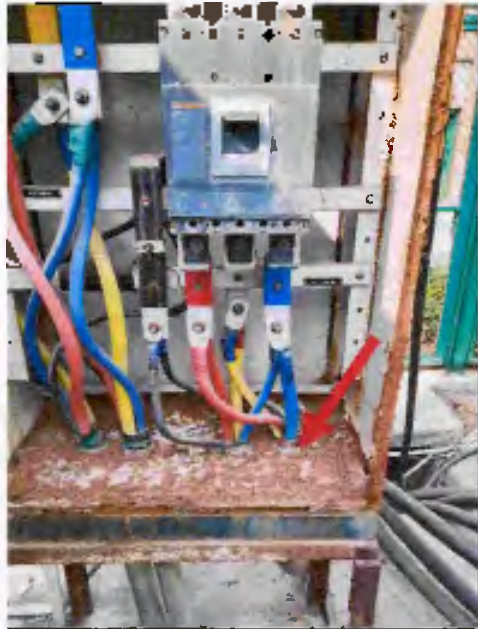
13-

Body is more or less got damaged due to rust and nut & bolts are also rusted.

-do-

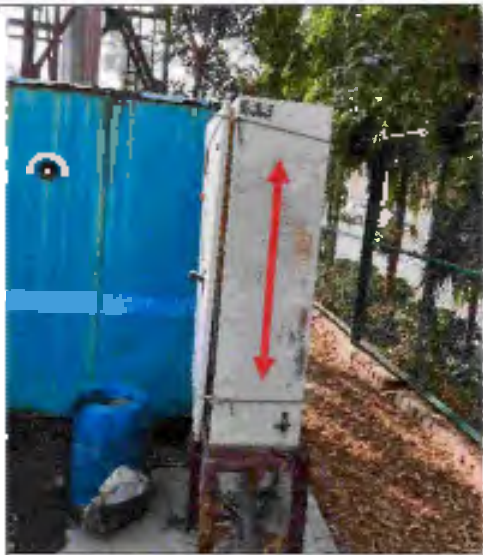
| 14- | | D.G electrical panel is tied with rope so due to this it is very difficult to protect the water entering in it. | Either shifts the panels in side under roof or fabricate a canopy for them. |

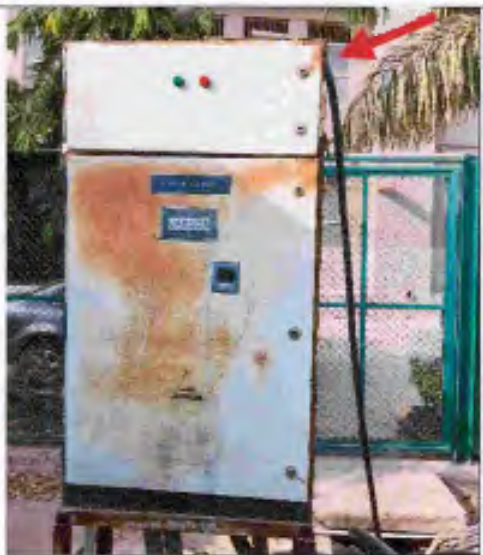
| 15- | | Diesel pipe was kept on electrical panel | There should be a separate hook to support diesel pipe & immediately remove the pipe from here. |

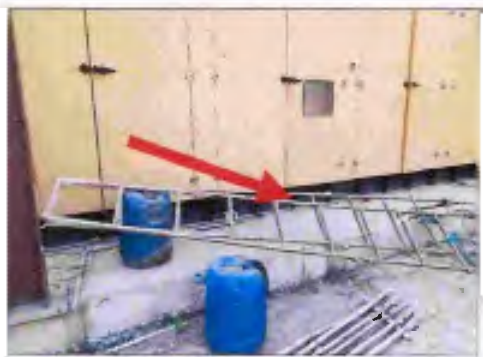
| 16- | | Ladder and other unwanted material were kept near D.G set which is HAZARD. | Keep clear space surrounding the D.G sets otherwise any casualty may occur. |

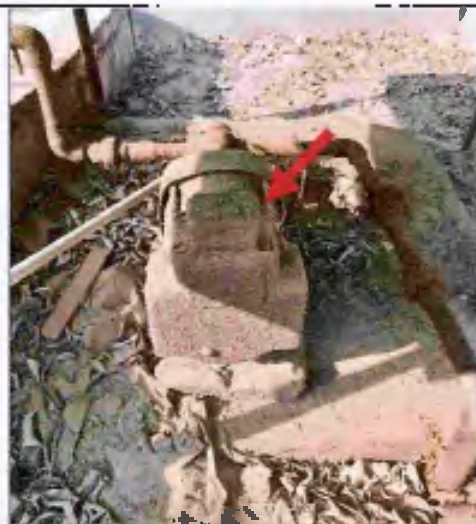
17-

Ordinary motor terminal box was fitted on diesel pumping motor.

It should be fire proof so immediate replace it.

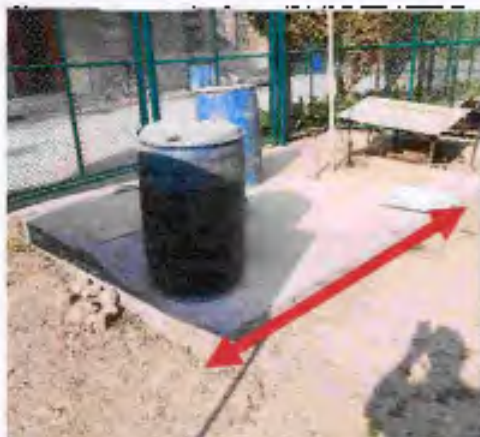
18-

NO fencing found for diesel storage tank there was thorough fare.

This is inflammable area so should be fenced throughly.

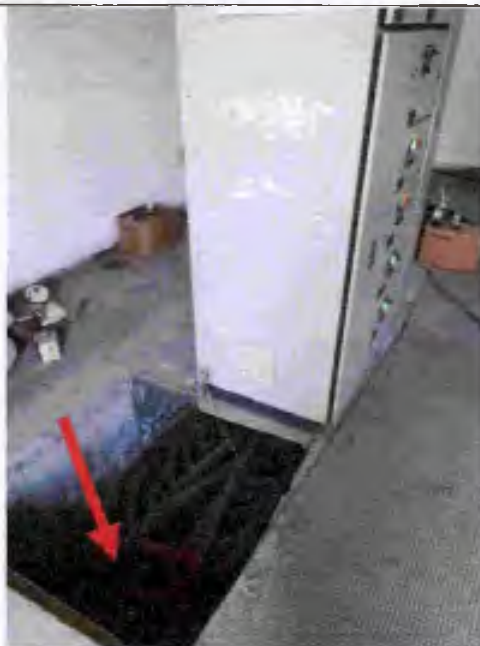
19-

In panel room near APFC panel cable trench was open and used as peakdan

Cover the trench properly with checkered plate.

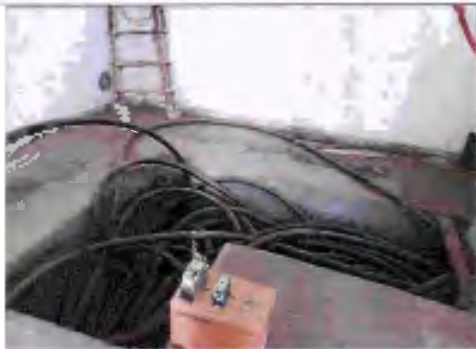
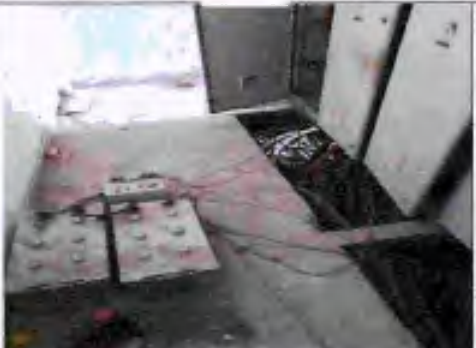
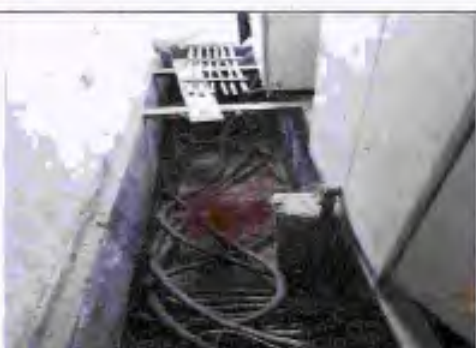
| 20- | | In L.T panel room the cable trench was not covered so it may be a cause of accident. | Cover the trench properly with checkered plate. |
| 21- | | -do- | do- |
| 22- | | -do- | -do- |

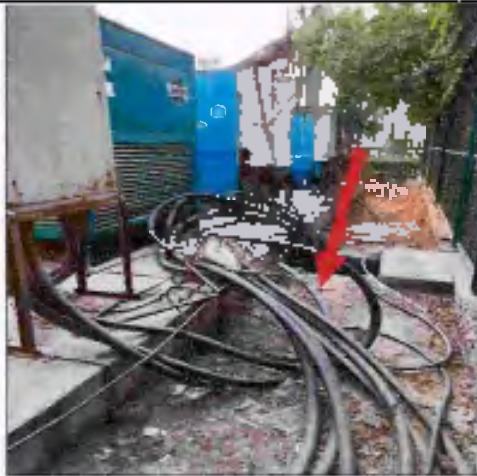
| 24- | | <p>In D.G area cables used for D.G sets are not dressed properly they laid in hapazzard manner.</p> | <p>Dressed the cable properly.</p> |

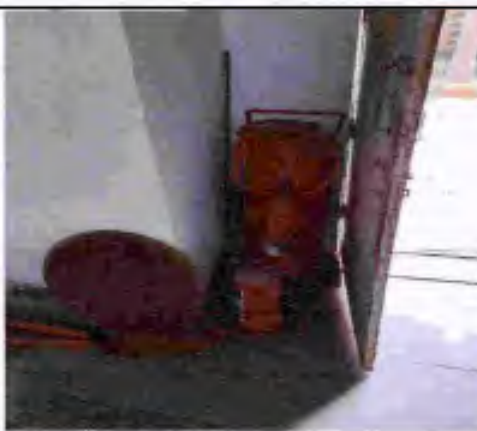
| 25- | | <p>Fire extinguishers are kept hidden i.e not properly installed.</p> | <p>Install them in proper way in easy access.</p> |

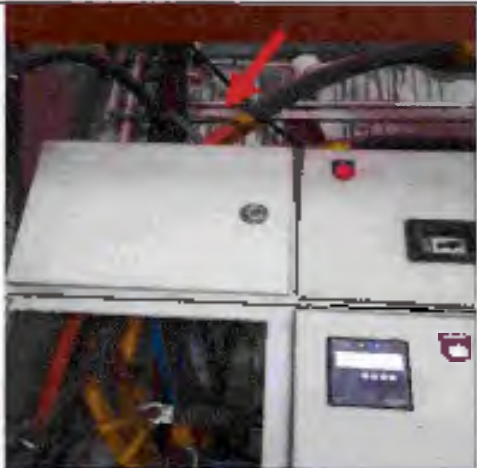
| 26 | | <p>Cables are terminated without the cable glands.<br/>It is in new building basement panel a side of civil lab.</p> | <p>Cables should be connected after using proper cable gland to reduce the tension from the cable connection terminals.</p> |

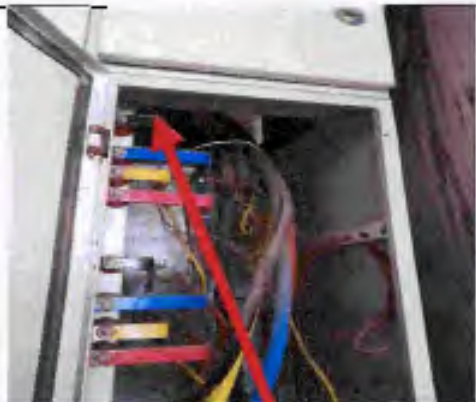
| 28- | | Cables are entering in panel without glands and top portion was open and inviting the entry of Lizards and Mouses. | Close the openings. |

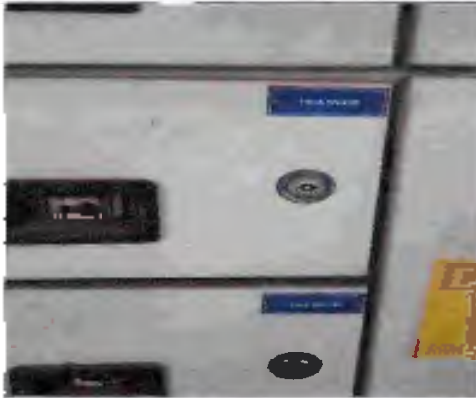
| 31- | | Nomenclature are not properly written so it is very difficult to identify the feeder locations. | Write the proper feeder name. |

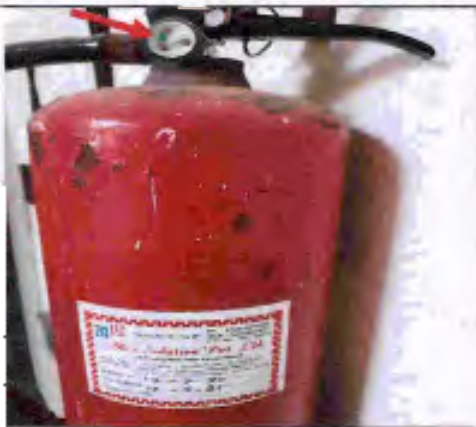
| 32- | | Fire extinguishers pressure needle in red zone but it valid up 2021 this is kept in old building alley. | Check it and rectify the issue otherwise it will not work during fire. |

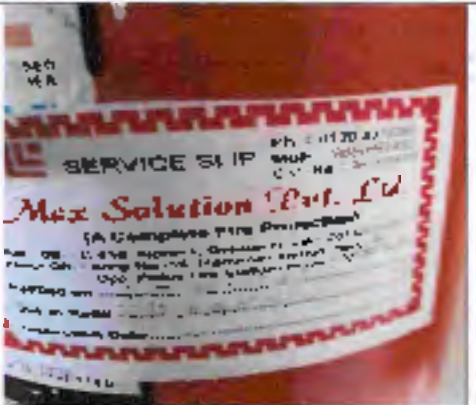
| 33- | | Old slip for validity was not changed. | Test the condition and change the validity slip. |

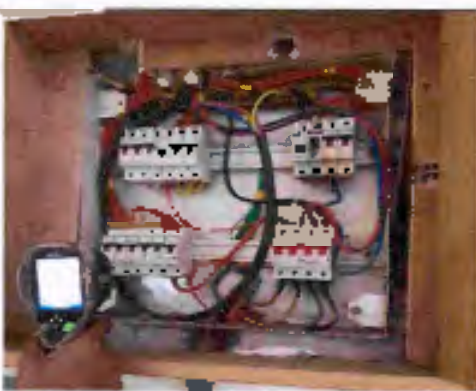
| 34- | | ELCB / RCCB are not installed, only isolater is connected in lighting D.B for both the buildings so during any fault the isolater will not trip. | Install a proper size ELCB OR RCCB from safety point of view. |

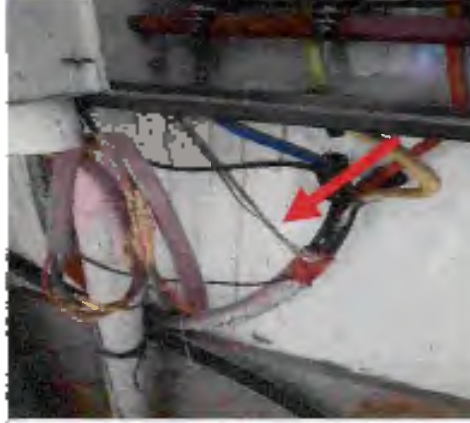
| 36- | | The cable armor is used as earth it violation of I.E rules. | Use proper earth connection wire duly connected with earth pit. |

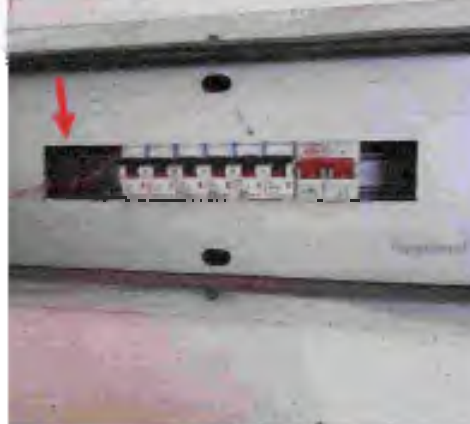
| 37- | | Openings were observed in lighting and power D.B. | Do not leave the openings in lighting D.B, use the blankers to cover the openings. |

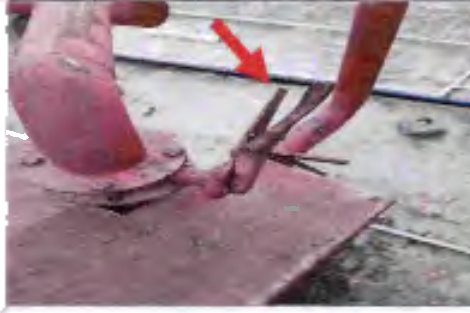
| 38 | | Fire fighting line main valve handle at roof found broken. | Attend it immediately. |

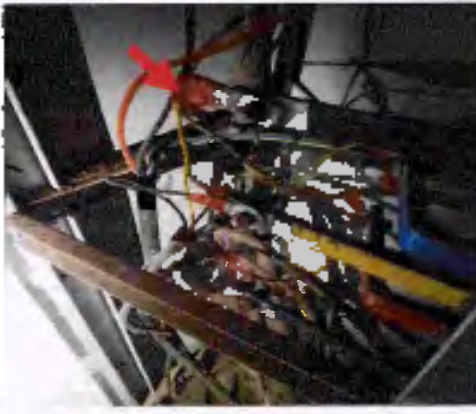
| 39- | | For old building panel Over size thimbles are used and not crimped properly and found jumbling of wires. | Use proper size thimbles ,crimp properly and dress the cables properly. |

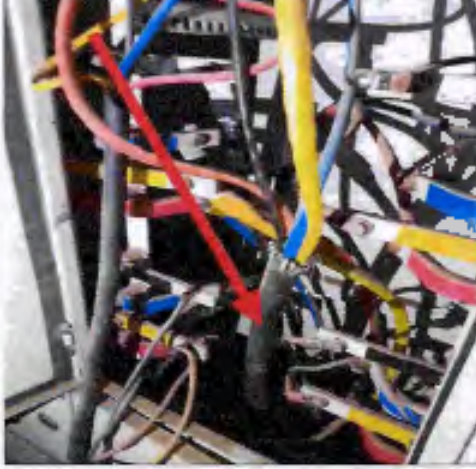
| 40- | | In old building basement panel cables are used without cable glands. | Use proper size cable gland otherwise pressure from the connection terminals can not be released |

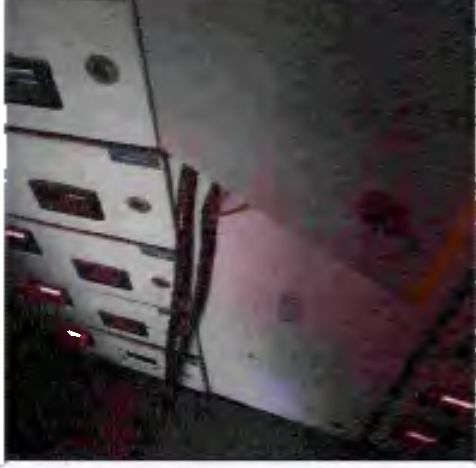
| 41- | | In old building panel cables are connected in this manner that cover was not closed properly. | Connect the cable in decent manner and close the cover properly. |
